## Surface Defect Report

## Typical Dent on Fuselage

| Project Name | dentCHECK-Demo | Created By | dentCHECK User | Scan Date | 05. Sep 25 |
| Comments | Typical SRM-Complaint Report for OEMs | | | | |

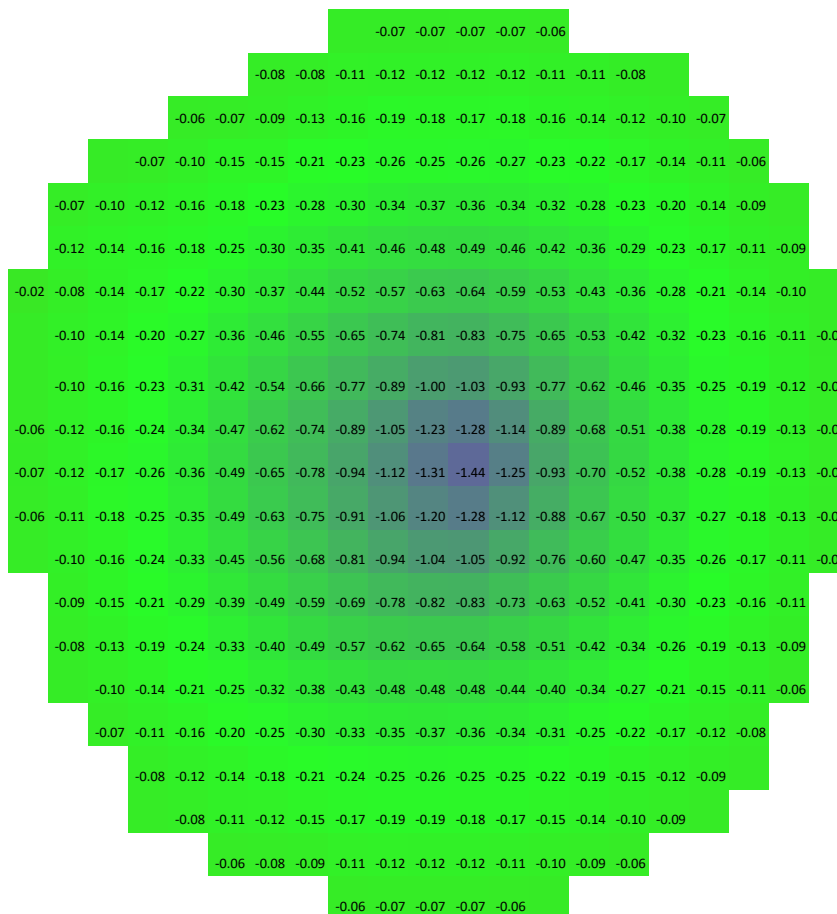
Defect Surface Map Axis: [mm] Map: [mm] Color Range -2.3 mm 2.3 mm

| Max Depth | -1.44 mm | Small Diameter | 61.7 mm | Region of Interest | 1 |
| Max Height | n/a mm | Big Diameter | 62.4 mm | Critical Ratio | 43 |

| Reference no. | Reference Name | Safety Margin | Dist: Maximum to STR/FR | Dist: Edge to STR/FR |
|---|---|---|---|---|
| 1 | FRAME 001 | 15.0 mm | 72.3 mm | 53.9 mm |
| 2 | STRINGER 001 | 15.0 mm | 89.4 mm | 72.9 mm |
