Airlines for  
America

A4A NDT FORUM - 2026

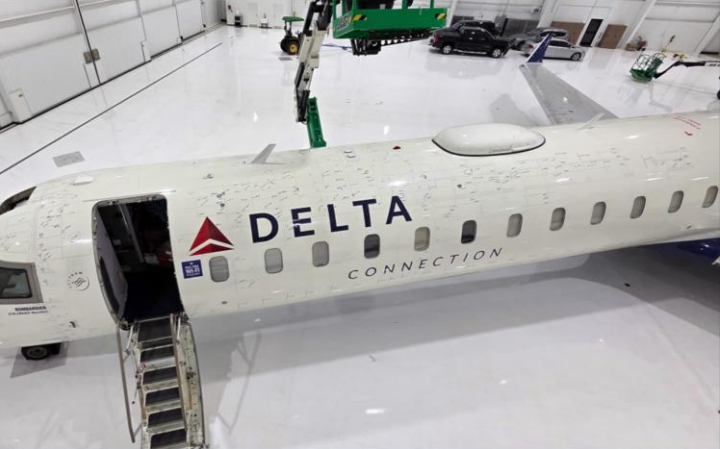
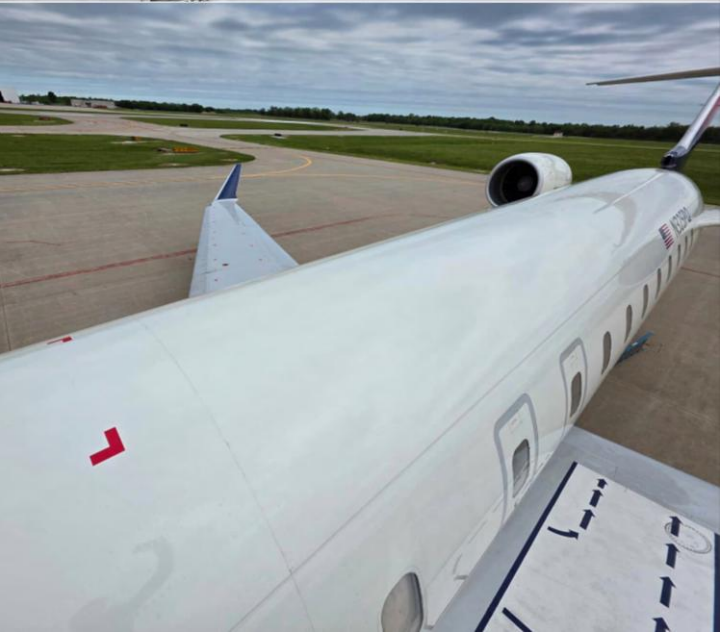
# Springfield Hail Damage Mapping

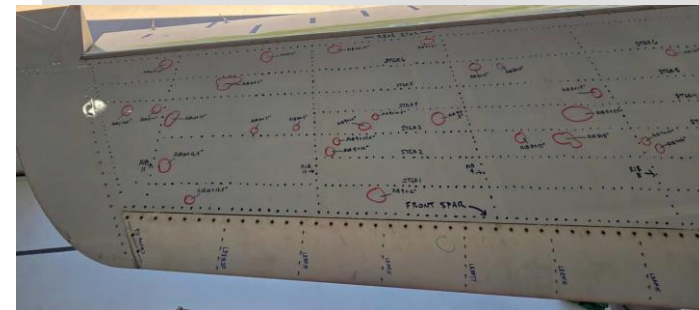
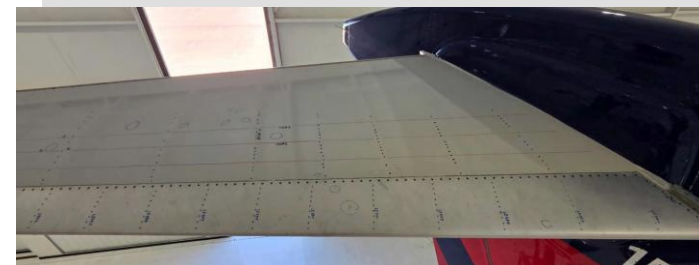
*Damage location overview on RH H-stab upper skin, RHS*

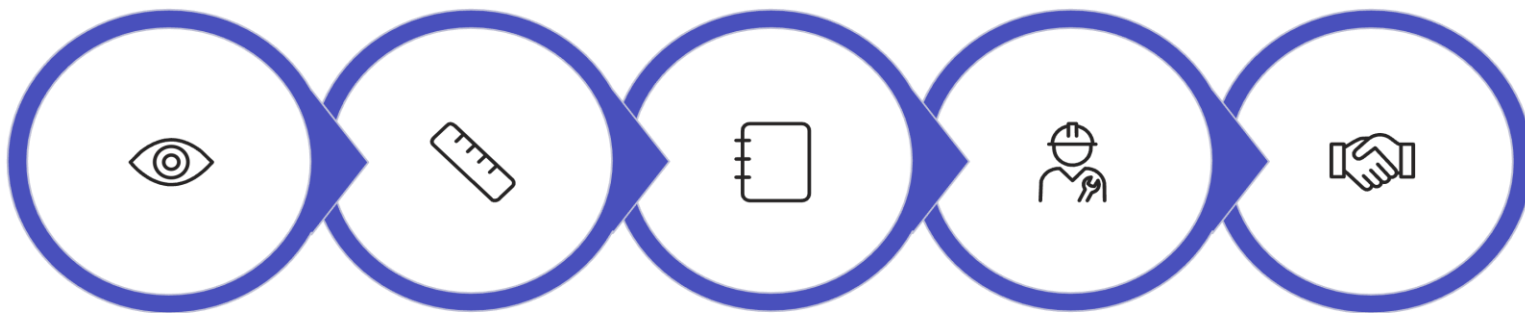
Deployed three scanners and a team of 7 to SFG to map damage and categorize by structural zones and severity.

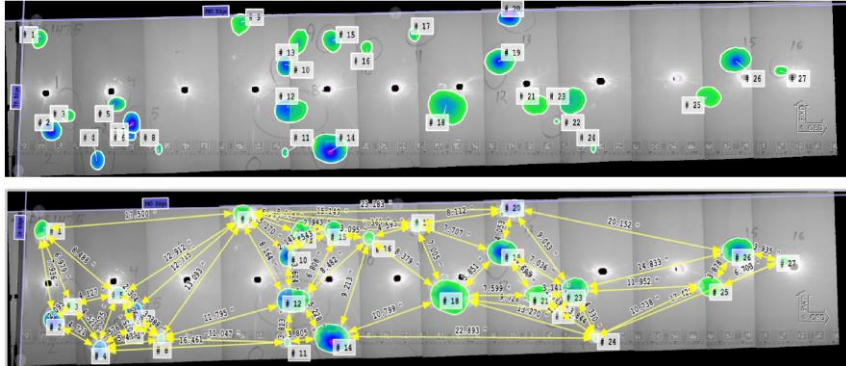
*"The Springfield hail event reinforced that large scale damage response is no longer just about inspection effort- it is about quality, speed, and precision."*

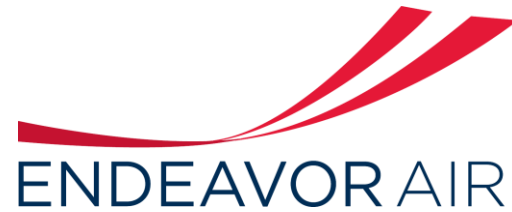
**Note:** Ultimately, this Springfield hail-incident established that our ability to respond effectively is directly tied to how quickly we can deliver reliable data-driven answers - not just how fast we can inspect.
