MRO operational efficiency-gains enabled by 'Go/No-Go' digital dent-mapping: A Case Study

*Cinthya Miguelis, Roberto Rocha (TAP-M&E)
Arun Chhabra, Pia Böttcher, Erik Klaas (8tree)*

September 26-29, 2016

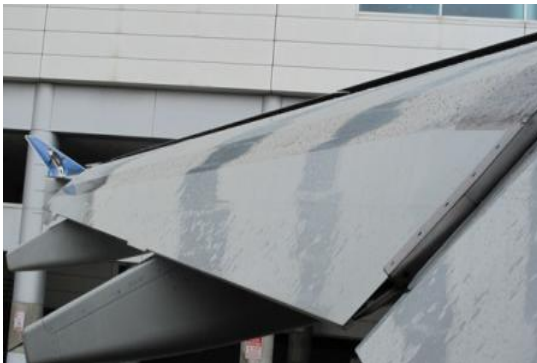
Hail Damage

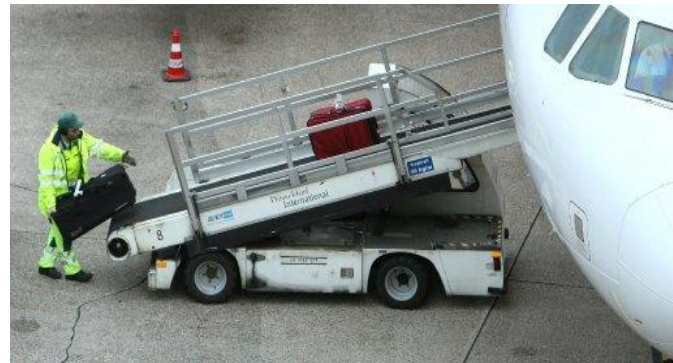
Damage due to ground equipment

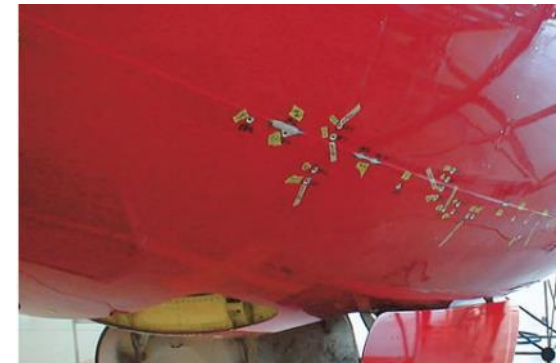
Lightning strike

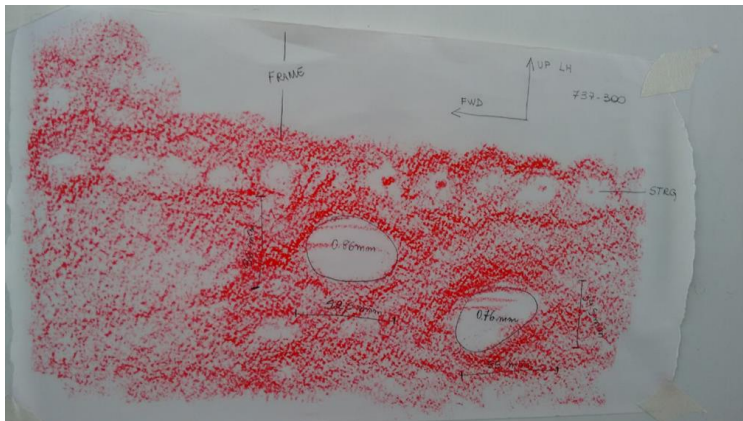
Dent Reports: Traditional Methods

Typical industry format

- Minimal identification data
- Basic numeric measurement values
- Relies on manual entry of location information
- Text-only, unless operator attaches a photograph / manual drawing of affected area

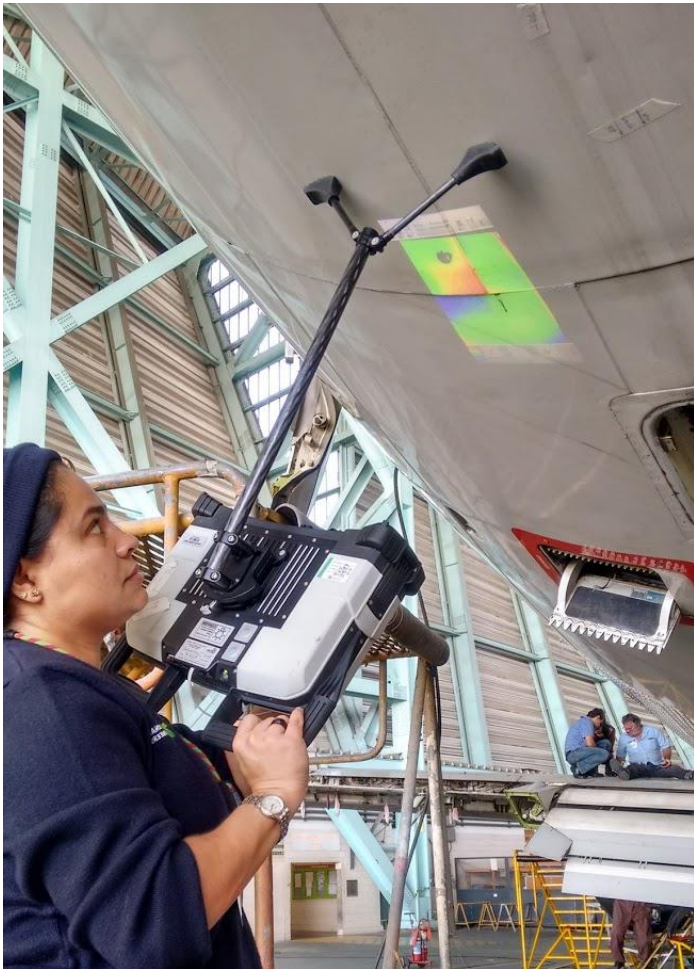
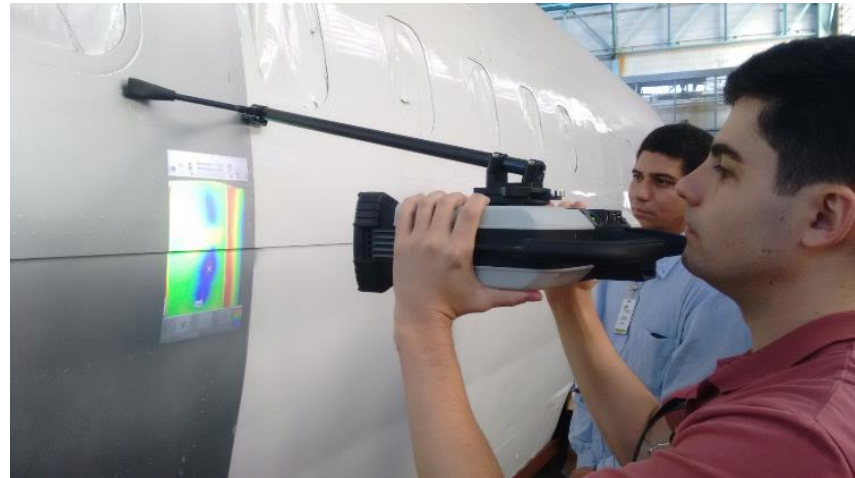
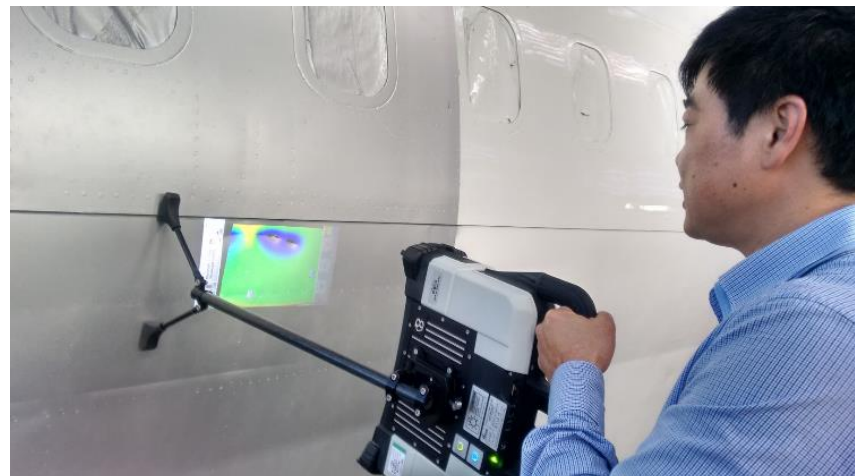
dent✓CHECK® – Go/No-Go Digital Mapping

- Never look away – eyes always on task!

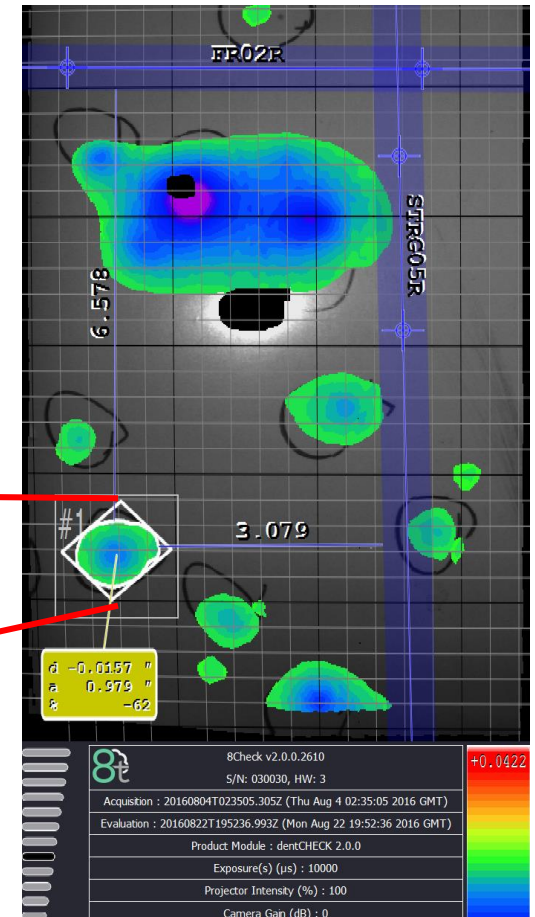
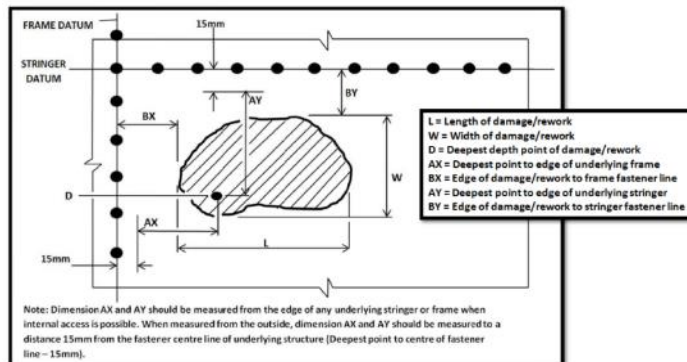
Dent Reports: dentCHECK®

- Image-based reporting format with traceable measurement values
- Measurement values extracted directly from SRM-compliant dentCHECK results

A / Y (or W / D)

Deepest point x-section

Distance to frame & stringer

Detailed log (operator ID, time-stamp, job #)

Color-coded annotation
