# Applying damage-mapping efficiencies to new aircraft induction with dentCHECK®

Neal Sleppy  
QC Technical  
Allegiant Air

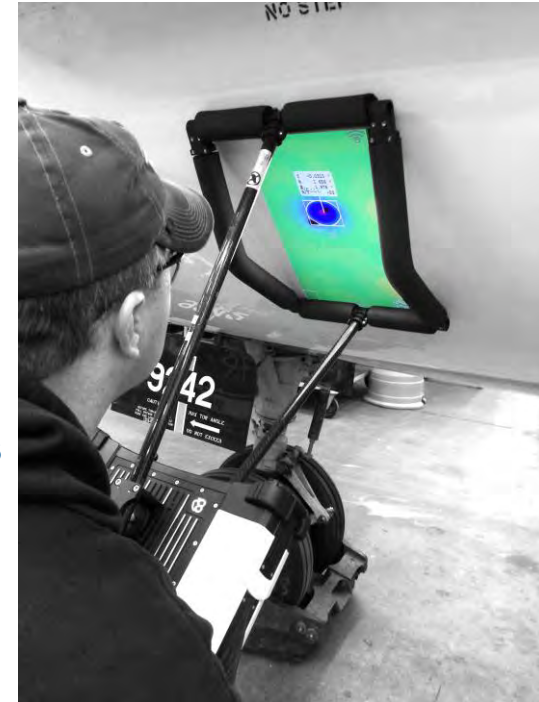
- The only OEM-certified handheld 'go/no-go' tool for 3D damage inspection that can claim the following –
  - Built-from-the-ground-up per requirements of airlines/MROs
  - Delivers actionable SRM-compliant answers (not just data!) in seconds
  - Inspects **dents, bumps and blend-outs**
  - OEM-approved for metal, composite, flat & curved surfaces
  - Fully self-contained system – **no external computer, no wires**
  - **Designed for any skill-level.** Just power-on, point-&-click
    - no pre-programming/configuration
    - no post-processing software
    - no surface preparation or stickers
- Used daily by dozens of airlines/MROs worldwide

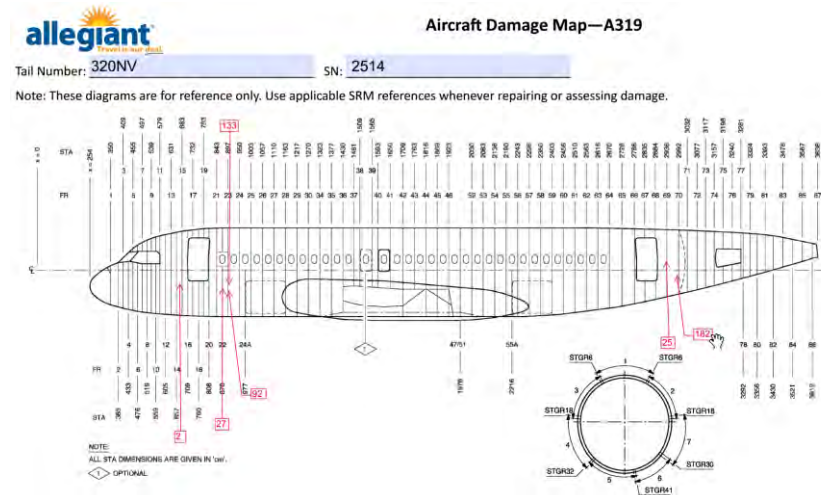
**Fuselage—Left**

- 9 dents/bumps
  - Primarily concentrated around Entry, Service and Cargo Doors
- Inspection & reporting – one-person task
- AC on Ramp, New Paint and Zonal Inspections completed by the MRO
  - Locate damage using existing d&b records
  - reposition GSE for better access to damage locations

**Time savings / efficiency gains = 87%**

Man Hours	
Traditional tools	dentCHECK
15 hours	2 hours

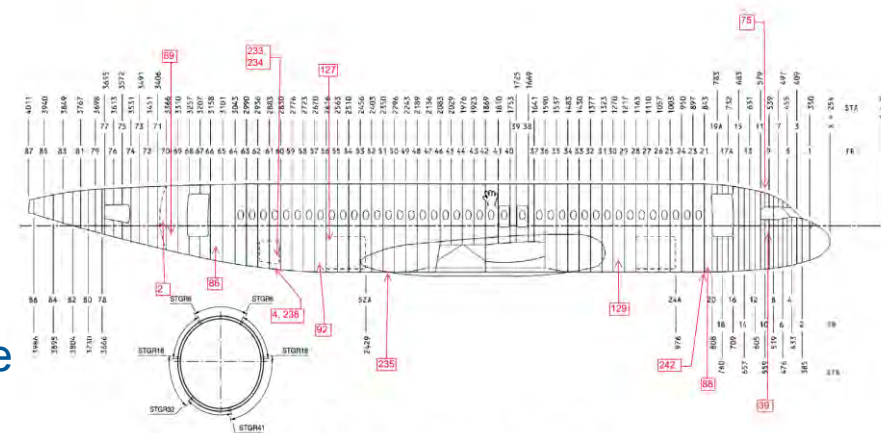
Aircraft Damage Map—A320

- 18 dents/bumps
  - Primarily concentrated around Entry, Service, Cargo Doors and FWD Fuselage
- Inspection & reporting – one-person task
- AC on Ramp, New Paint and Zonal Inspections completed by the MRO
  - Locate damage using existing d&b records
  - reposition GSE for better access to damage locations

Fuselage—Right

Man Hours	
Traditional tools	dentCHECK
27 hours	4 hours

Time savings / efficiency gains = 85 %

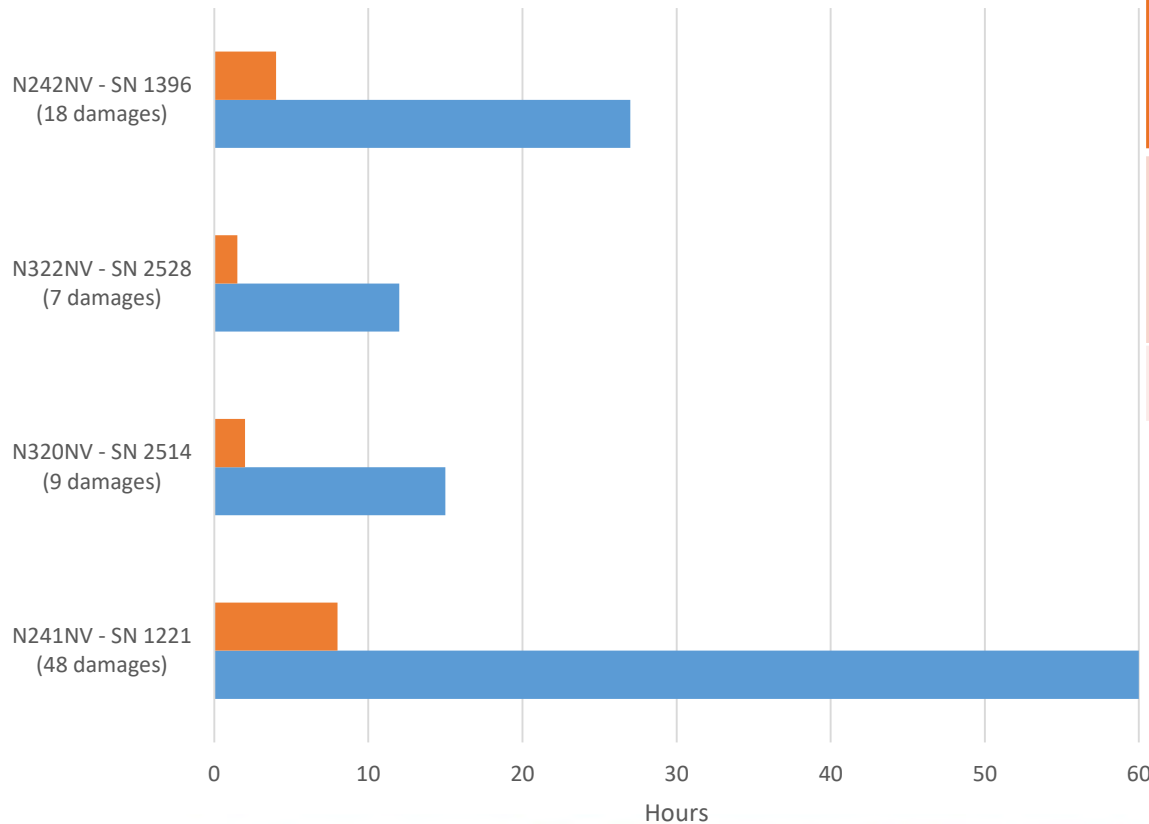
## Measurement & Reporting Time / Damage

Time taken to INSPECT & REPORT damage

*Average of all aircraft inspected (minutes)*

Traditional Measurement Technique	92
dentCHECK	12

dentCHECK  
Traditional Tools

**87% Time savings with dentCHECK**

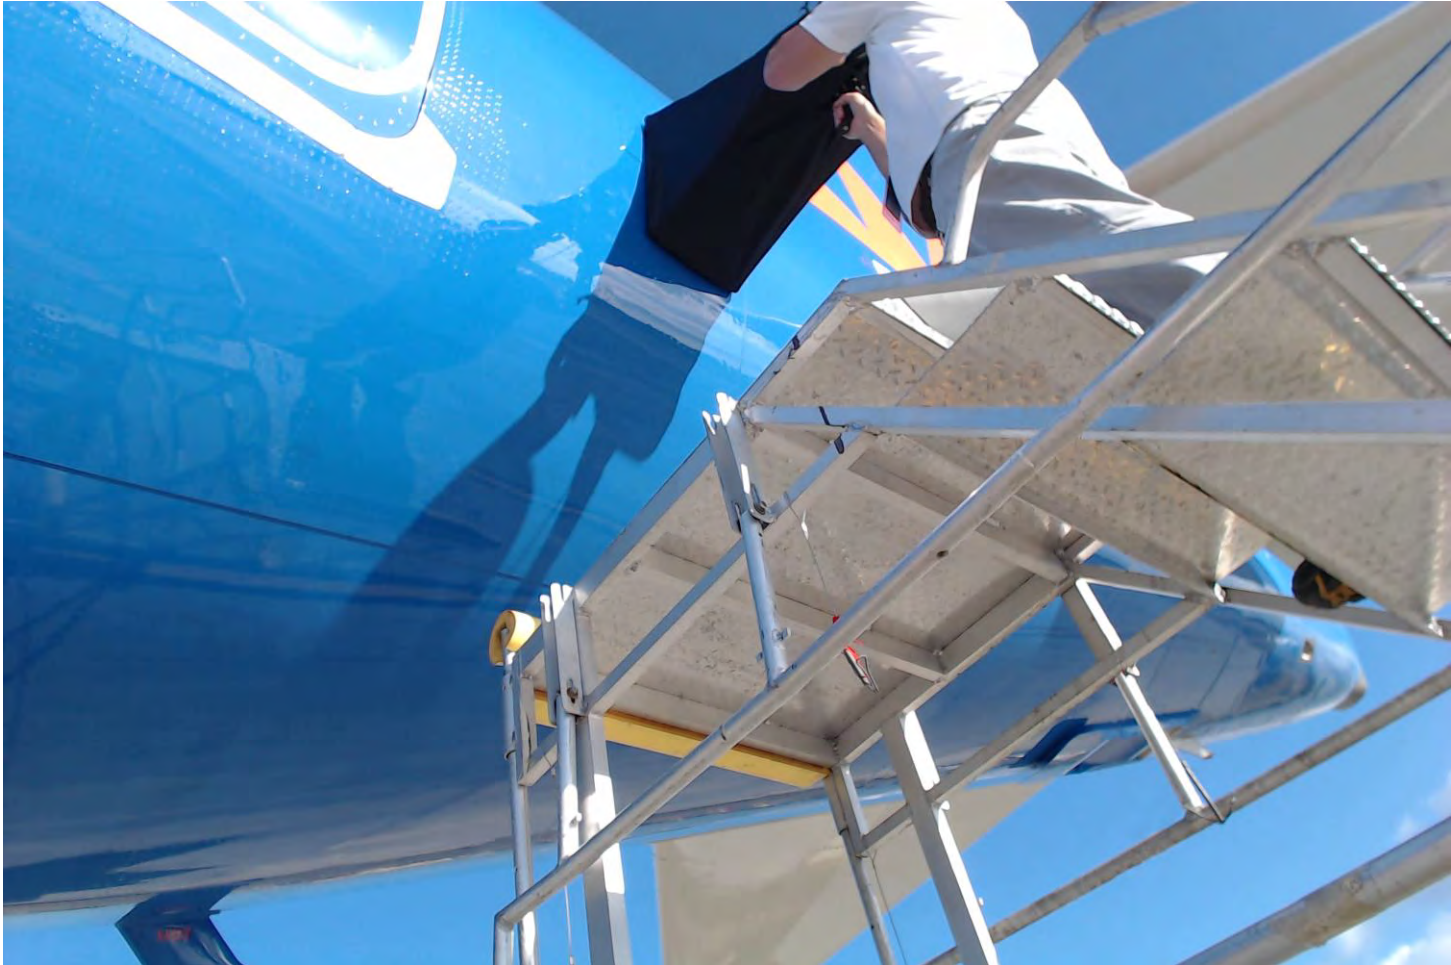
# dentCHECK in use at Allegiant's MRO (LHT-BQN)

- dentCHECK reports reconciled with AC pre-existing damage records
- Any differences between dentCHECK & pre-existing damage reports were re-measured with mechanical methods
- dentCHECK mapping was consistently found to be more precise
- dentCHECK's continuously expanding capabilities, including 8cloud and blend-out integration make it a very compelling tool in our toolkit
- Allegiant is eagerly committed to exploring implementation of dentCHECK across it's maintenance operations.
