Surface Defect Report (Multi Dents/Bumps)

Project Name	panoLite	Tool Number		Report Date	09. Mrz 21
Created By	Operator X	Scan Date	09. Mrz 21	Registration / Tail No.	[Registration]
Work Order No.	[WOnumber]	Flight Hours	[FlightHours]	Serial / MSN	[AircraftSerial]
Carrier	[Carrier]	Flight Cycle	[FlightCycles]		
Comments

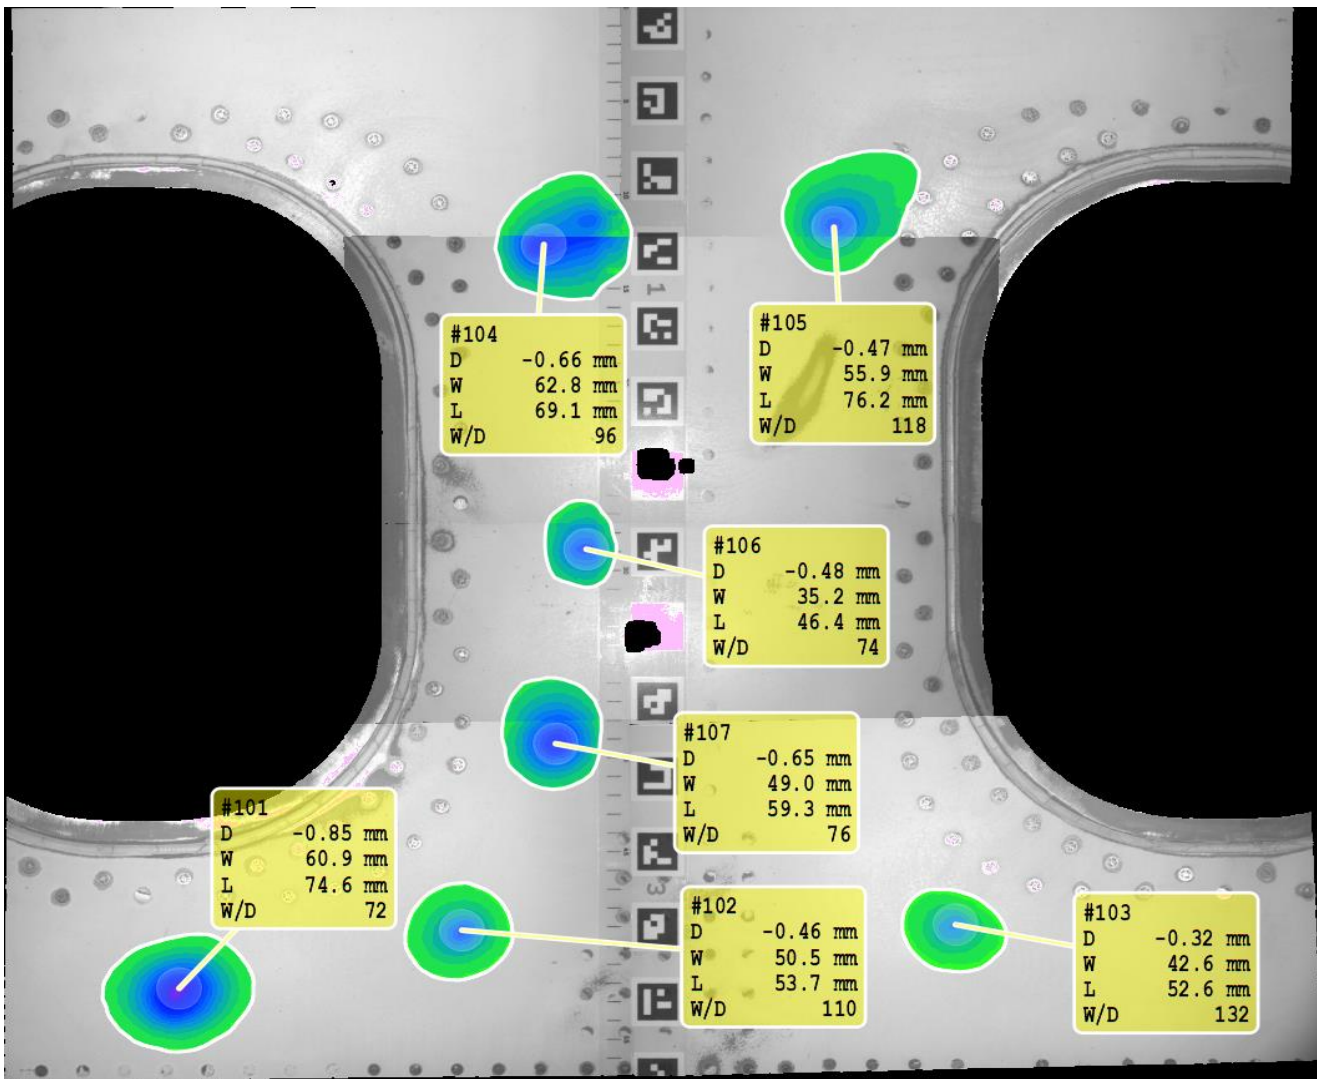
Screenshot

Dent / Bump Measurement			Unit mm		Safety Margin		15.0 mm
ID	Defect	Deviation	Small Diameter	Big Diameter	Ratio	Closest Dent ID	Distance
101	Dent	-0,85	60,9	74,6	72	106	77,2
102	Dent	-0,46	50,5	53,7	110	107	60,4
103	Dent	-0,32	42,6	52,6	132	107	170,7
104	Dent	-0,66	62,8	69,1	96	105	74,9
105	Dent	-0,47	55,9	76,2	118	104	74,9
106	Dent	-0,48	35,2	46,4	74	107	50,2
107	Dent	-0,65	49,0	59,3	76	106	50,2

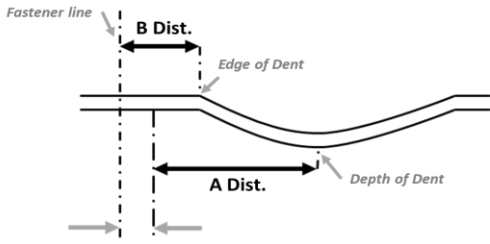
Standard safety margin: 15 mm (0.59 in.)
