MRO operational efficiency-gains enabled by 'Go/No-Go' digital dent-mapping:

A Case Study

*Cinthya Miguelis, Roberto Rocha (TAP-M&E)
Arun Chhabra, Pia Böttcher, Erik Klaas (8tree)*

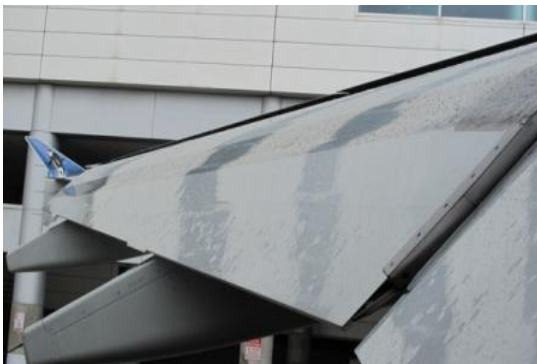
Hail Damage

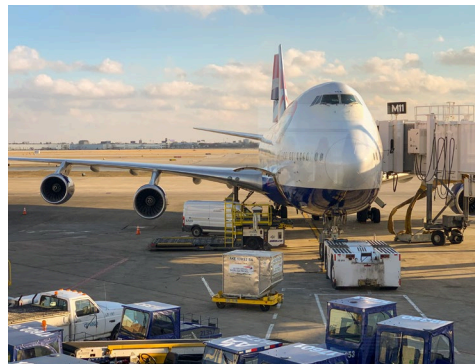
Damage due to ground equipment

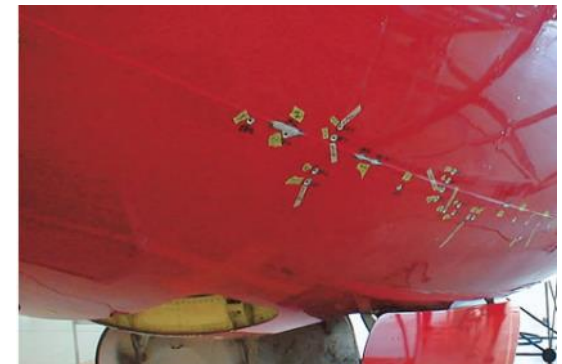
Lightning strike

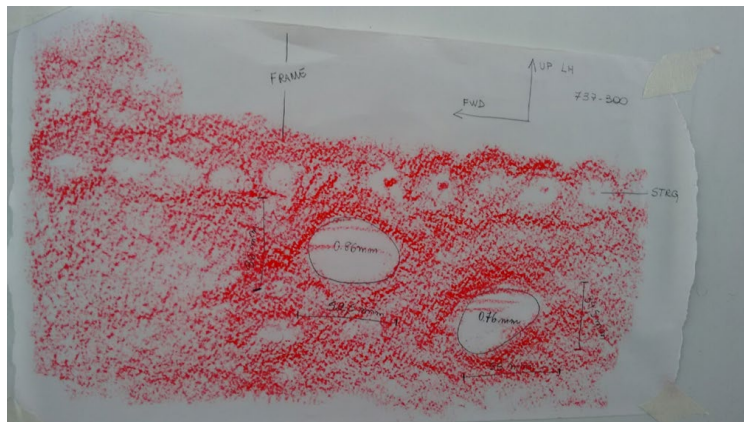
Typical industry format

- Minimal identification data
- Basic numeric measurement values
- Relies on manual entry of location information
- Text-only, unless operator attaches a photograph / manual drawing of affected area

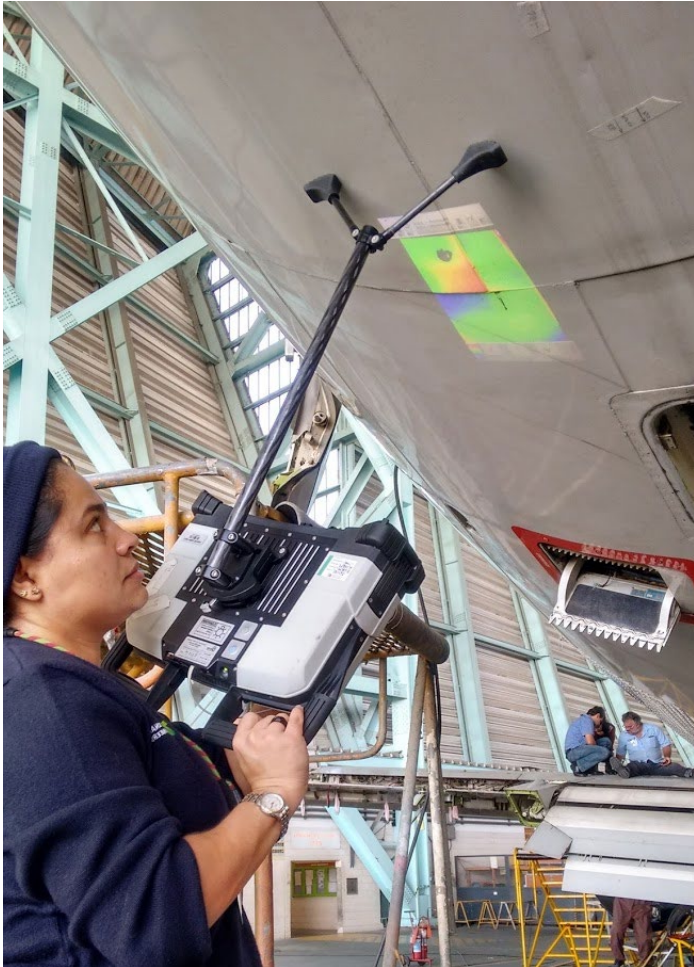
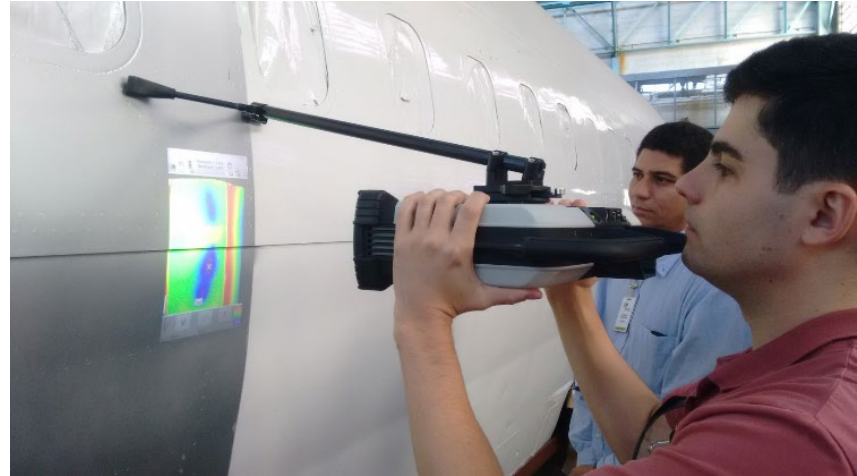
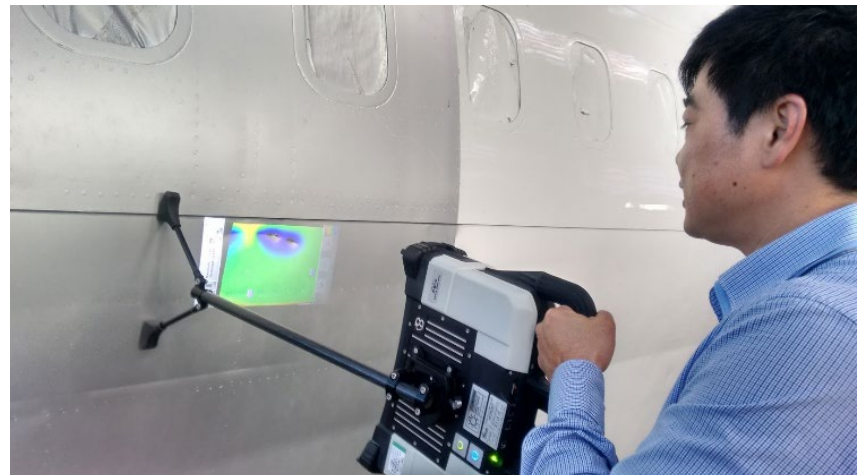
dent✓CHECK® – Go/No-Go Digital Mapping

- Never look away – eyes always on task!

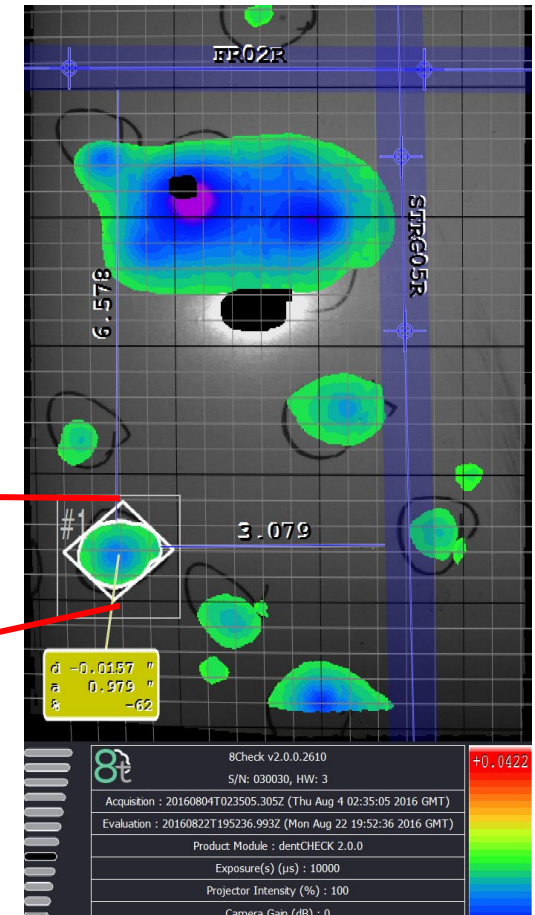
- Image-based reporting format with traceable measurement values
- Measurement values extracted directly from SRM-compliant dentCHECK results

A / Y (or W / D)

Deepest point x-section

Distance to frame & stringer

Detailed log (operator ID, time-stamp, job #)

Color-coded annotation
