## Case Study

### **Hail damage dent and buckle check with dentCHECK during aircraft phase-out**

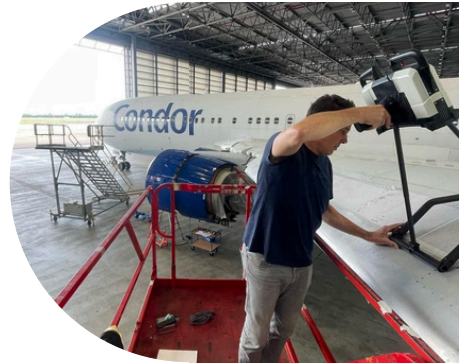
## Why dentCHECK 3D Dent-Mapping by AMROS Global & 8tree?
