# Inspection Technologies for Wind Turbine Rotor Blades

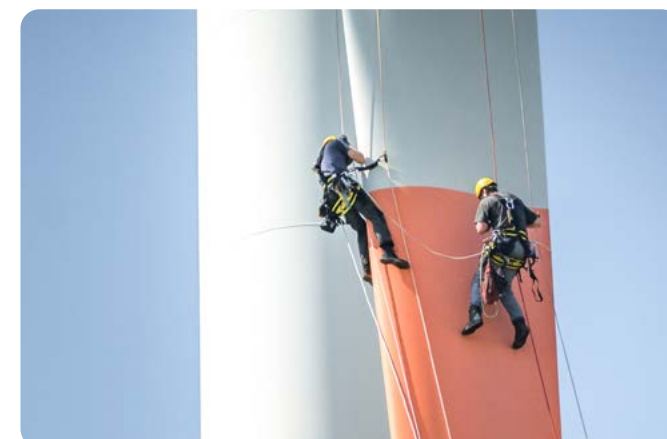
## Expert inspection

Inspection of rotor blades by experienced experts, supported by non-digital tools like torches, steel ruler, caliper and contour gage has been state of the art for a long time. In the last 20 years, we have seen more rotor blade inspections supported by various non-destructive testing methods. But even today, visual inspection, completed by measuring, raying by torch, and tapping the blade surface, plays an important role. Even in the 2020s, it is nearly impossible to comprehensively inspect a rotor blade without relying upon the knowledge of an experienced expert in that field. This truth is even more apparent when it comes to rotor blades mounted to turbines in the field, where blade accessibility is complicated and sometimes limits the ability to use sophisticated technology. Through increased use of inspection robots and drones, these challenges will obviously dissipate. In the end, the final judgment regarding a defect's severity and need for repair is in the hand of a single or team of experienced technical experts.

| | EASE OF USE/<br>FLEXIBILITY | SUITABILITY FOR<br>DEFECTS BELOW<br>SURFACE | RESOLUTION | REQUIRED<br>OPERATOR<br>TRAINING | REQUIRED<br>EVALUATION<br>EFFORT |
|---|---|---|---|---|---|
| EXPERT<br>INSPECTION | ++ | + | ○ | -- | ○ |

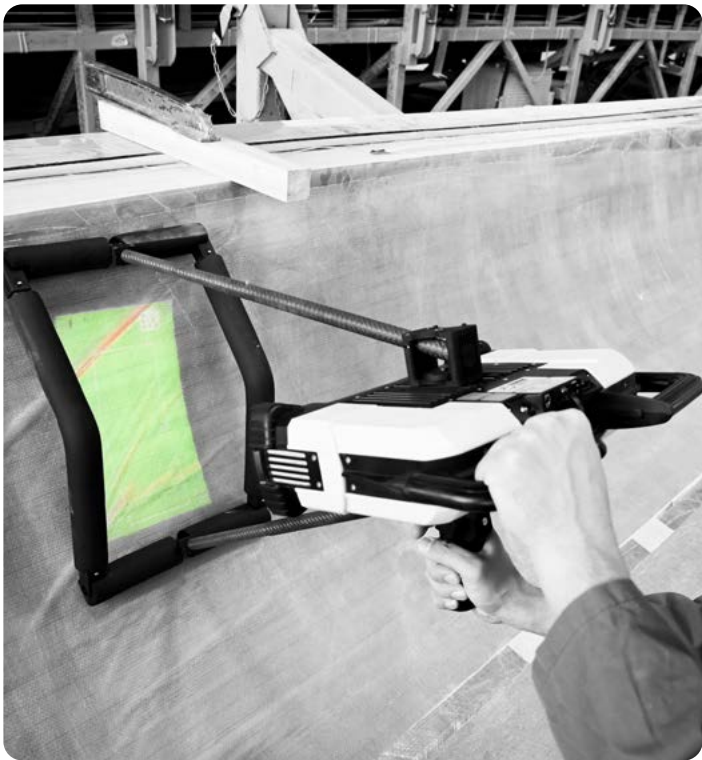
## OPTICAL SURFACE INSPECTION

For more than 20 years, Optical 3D scanners have been an integral part of quality control in the automotive and aviation industry. Nowadays, optical 3D scanners are also used in the wind turbine rotor blade industry, where they increasingly complement and replace traditional manual measuring equipment. SLI (structured light illumination) is a widely used technology. A structured pattern is projected onto the scanned surface and captured by a camera from a different angle. High measuring speeds ( $\ll 1s$ ), resolutions and accuracies (millions of measuring points and accuracies in  $\mu m$ -magnitude) are characteristics of the method. Because the physics of the measurement principle restricts the analysis of defects hidden in deeper layers, only artifacts and defects visible on the surface can be measured. Moreover, scanned surfaces must neither be extremely specular nor light-transmissive. In such cases, the surface may require pre-treatment to enable scanning.

Optical 3D surface scanning provides outstanding capabilities to reproducibly and accurately measure defects or features on surfaces such as waviness, wrinkles, steps, gaps, chamfers, radii, etc. Today, intuitive user interfaces and software make 3D scanners very user-friendly and require a low level of training.

| | EASE OF USE/<br>FLEXIBILITY | SUITABILITY FOR<br>DEFECTS BELOW<br>SURFACE | RESOLUTION | REQUIRED<br>OPERATOR<br>TRAINING | REQUIRED<br>EVALUATION<br>EFFORT |
|---|---|---|---|---|---|
| OPTICAL<br>SCANNING | ++ | -- | ++ | ++ | + |
