Case Study

Hail damage dent and buckle check with dentCHECK during aircraft phase-out

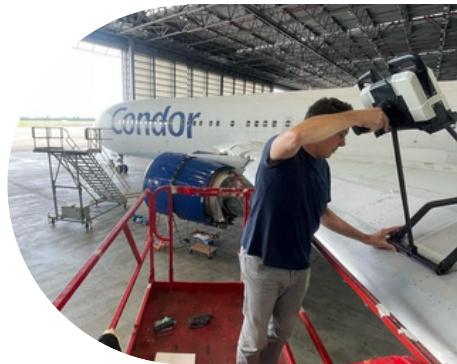
Why dentCHECK 3D Dent-Mapping by AMROS Global & 8tree?
